Contract #: 04-0120F4Cty: SF/ALA Rte: 80 PM: 13.2/13.9File #: 69.28**WELDING INSPECTION REPORT****Resident Engineer:**Siegenthaler, Peter**Address:** 333 Burma Road**City:** Oakland, CA 94607**Report No:** WIR-023697**Date Inspected:** 14-May-2011**Project Name:** SAS Superstructure**OSM Arrival Time:** 700**Prime Contractor:** American Bridge/Fluor Enterprises, a JV**OSM Departure Time:** 1900**Contractor:** Zhenhua Port Machinery Company, Ltd (ZPMC), Changxing Island **Location:** Shanghai,China**CWI Name:** Liu Hua Jie/Lv Li Qing**CWI Present:** Yes No**Inspected CWI report:** Yes No N/A**Rod Oven in Use:** Yes No N/A**Electrode to specification:** Yes No N/A**Weld Procedures Followed:** Yes No N/A**Qualified Welders:** Yes No N/A**Verified Joint Fit-up:** Yes No N/A**Approved Drawings:** Yes No N/A**Approved WPS:** Yes No N/A**Delayed / Cancelled:** Yes No N/A**Bridge No:** 34-0006**Component:** OBG**Summary of Items Observed:**

OBG Trial Assembly

WELDING INSPECTION REPORT

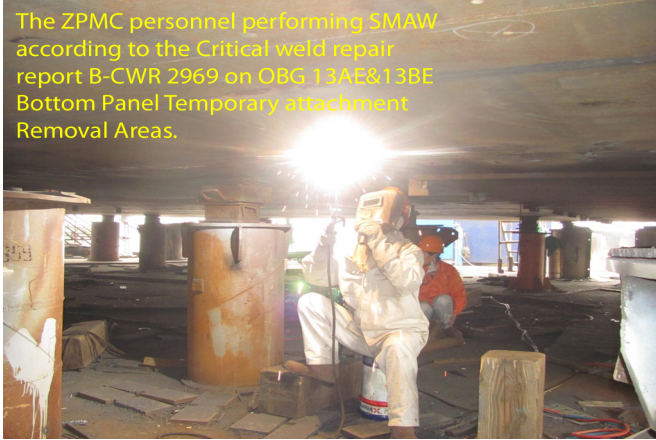
The ZPMC personnel performing SMAW according to the Critical weld repair report B-CWR 2969 on OBG 13AE&13BE Bottom Panel Temporary attachment Removal Areas.

SMAW welding of Bottom Panel temporary attachment removal areas located on OBG Segment 13AE. Welder is identified as #067572. ZPMC CWI is identified as Mr. Liu Hua Jie. Welding was performed with the Critical weld repair report CWR-2969. The welding variables recorded by QC appeared to comply with the WPS-345-SMAW-4G(4F)-FCM-Repair-1. Please see the attached picture.

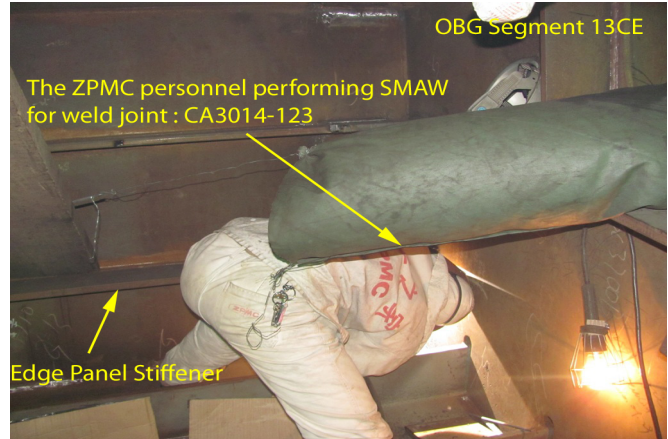
The ZPMC personnel performing SMAW for weld joint : CA3014-123

Edge Panel Stiffener

SMAW in the 4G position for the OBG Segment 13CE Edge Panel Stiffener. The weld joint was designated as: CA3014-123. The welder is identified as #066258. ZPMC CWI is identified as Mr. Lv Li Qing. The welding variables recorded by QC appear to comply with WPS-B-P-2214-B-U2-FCM-1. Please see the attached picture.
